NASA Technical Memorandum 79091

**EVALUATION OF A BRAYTON CYCLE RECUPERATOR
AFTER 21,000 HOURS OF GROUND TESTING**

**Thomas J. Moore
Lewis Research Center
Cleveland, Ohio**

February 1979

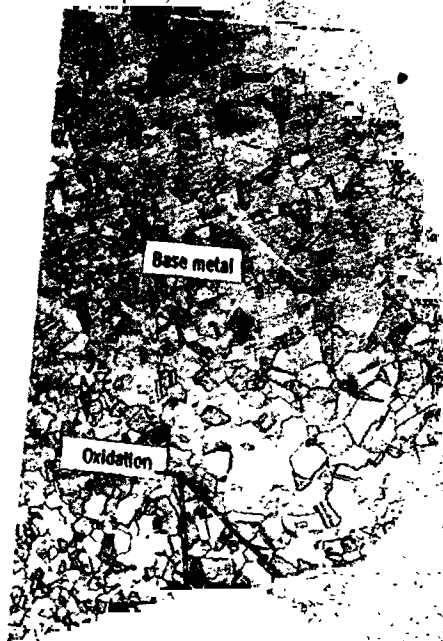
Sections were taken from the type 347 stainless-steel ducting at the hot end of the recuperator at the locations shown in figures 3(b) and 10 using electrodischarge machining (EDM) techniques. Sections 1A-1 and 1A-2 from the inlet ducting were examined and were found to be sound. However, the microstructure of section 1A-2 (fig. 11(a)) shows a minor scallop oxidation pattern at the inside surface of the weld. Section 1B at the outlet ducting was also free of flaws except for one slightly oxidized area at the inside surface (fig. 11(b)). Additional sections were taken further downstream in the outlet ducting (see figs. 3 and 12). Although the welds and base metal were sound (sections 1F, 1G, and 1H), localized minor oxidation was observed on the inside surfaces of the welds and base metal (fig. 13). In all of these areas in the ducting the oxidation is considered of minor significance because the affected area is a small percentage of the wall thickness.

(a) Thin oxidation layer at inside of
weld joint, section 1G.

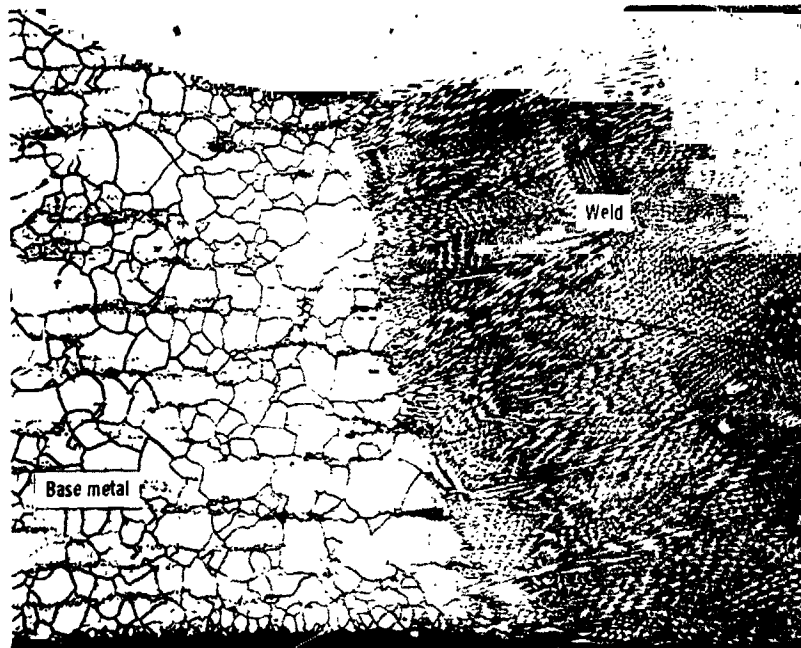
The gas tungsten arc girth weld between the knob and the flange (section 1C-2 in figure 17) was sound as shown in figure 19(a). Edge-flange weld 1C-3 was also sound (fig. 19(b)). The other gas tungsten arc welds 1C4, 1E, and 1X (fig. 17) were also free of flaws.

(a) Flange side of butt joint 1C-2.

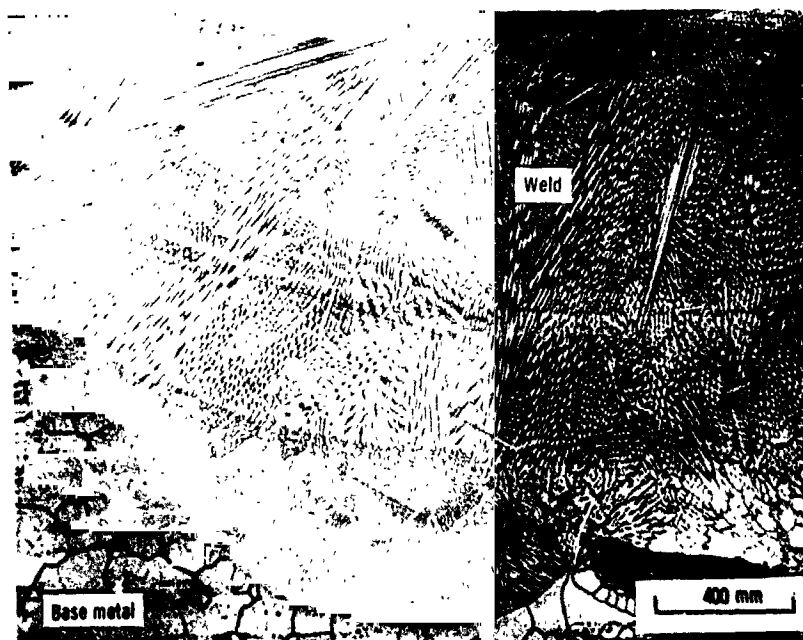
(b) Edge - flange weld 1C-3.

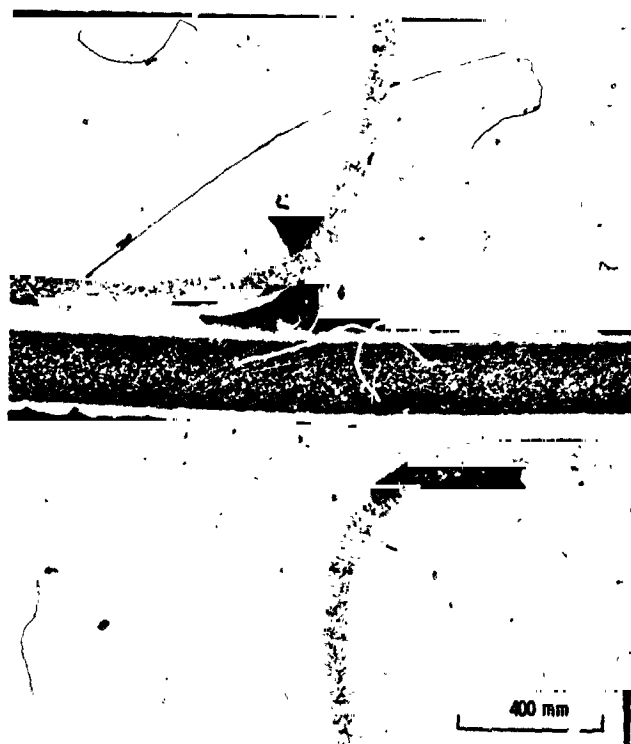
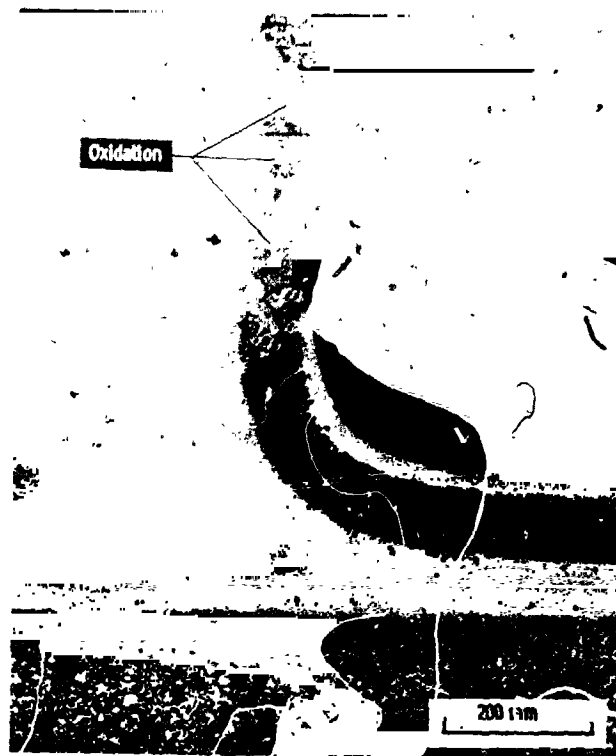
675° C, 800° C, and 1000° C. The results are shown metallographically in figure 22. At 675° C, oxidation of the stainless steel does not appear to be a problem. At 800° C, surface oxidation is evident. In addition, at one location oxidation has proceeded half-way through the wall of the fin. Thus, if a temperature exposure occurs in the vicinity of 800° C for 100 hours in a stagnant air environment, severe oxidation of type 347 stainless steel can be anticipated. Exposure to 1000° C for 100 hours completely destroys the thin-wall fins. These results suggest that the recuperator may have experienced higher temperatures than 675° C.

(a) Oxidation free fins after 100 hours at 675 C.

(b) Surface and internal oxidation after 100 hours at 800 C.

(b-1) Complete oxidation of the fins after 100 hours at 1000 C.
